Service Bulletin

| Affected product: | TAZ 3D printers, versions 4.1 and below |
| Service issue: | When printing a tall object, the extruder wiring harness can potentially be caught on the printed model, leading to print failure. The installation of an additional zip-tie can minimize the risk of this occurring. |

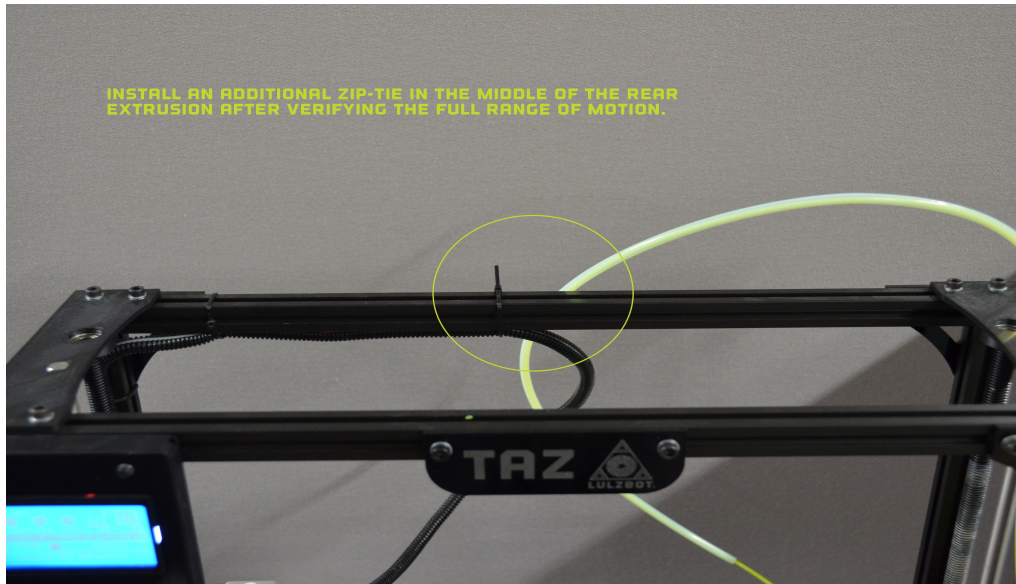
Some users have reported that when printing a tall object the extruder harness can be caught on the model, leading to print failures.

Install an additional zip-tie onto the top-rear aluminum extrusion, approximately 200mm away from the original zip-tie holding the extruder harness. Installation of the additional zip-tie in the middle of the top-rear extrusion does not need to be exact. Verify full axis travel range prior to installing the zip-tie.
